# **PUBLIC SITE & BUILDING COMMISSION**

## **Special Meeting Minutes**

**Tuesday December 8, 2009**

Town of Bethel Firehouse  
April 14, 2009  
*Revised December 7, 2009*  
Punch List 11:00AM at Site

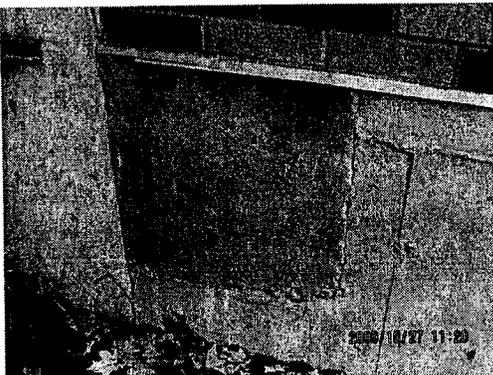
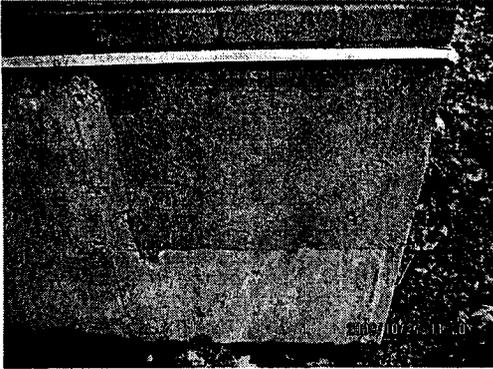
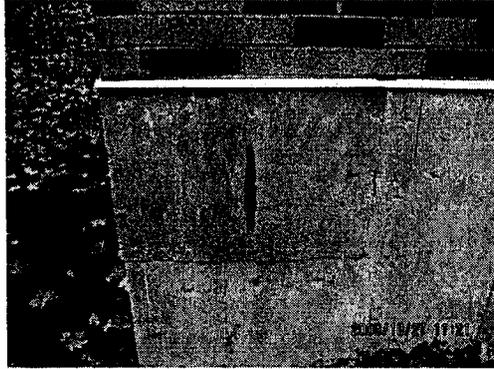
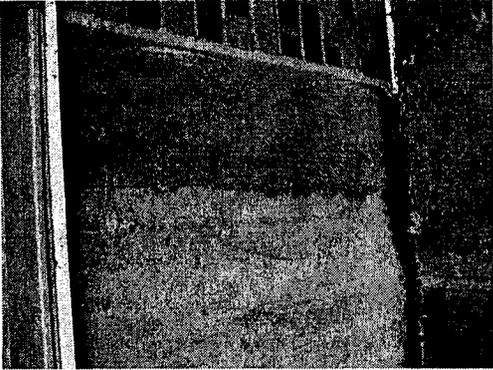
8. There is a patch in the concrete foundation immediately below the electric panel that is not tight against the rest of the foundation and there is one at the southwest corner of the building. The joints must be filled. *(See photos 1-4 taken 10/27/09) which also show a crack in the foundation on the east side near the elevator shaft. This should be filled.*

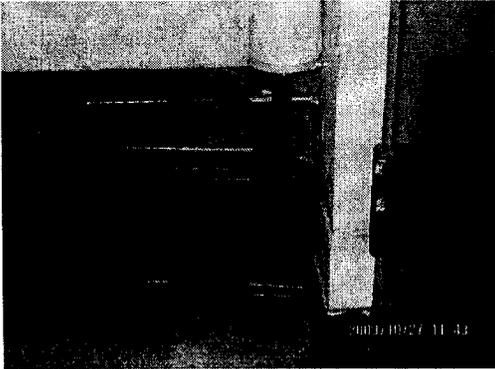
(5)

11. There is a crack already appearing at the southeast corner between the masonry walls. *This joint has opened up again. Apparently the interior wall was not properly tied into the exterior wall. A more permanent correction for this vertical joint needs to be provided. (10/27/09 Photo #5)*

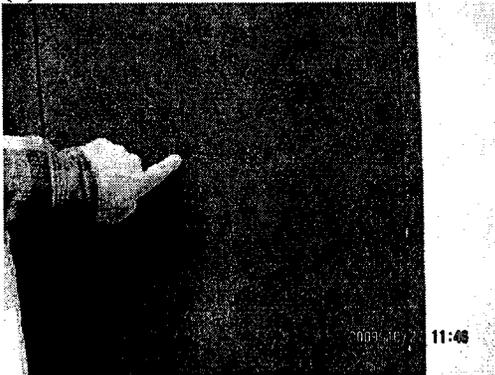
(6)

1. At the top landing the end cap of the baseboard radiation was never reinstalled. A cap shall be provided. *The vertical copper pipe installed as part of this work was done in such a manner as to not allow the end cap to be properly installed. The*

pipe should be reworked to be within the enclosure and the vertical portion of the end cap installed correctly. See Photo #6.

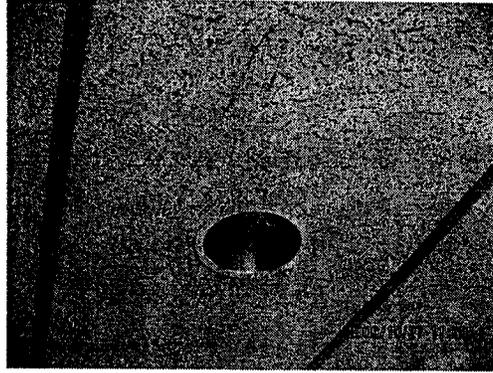
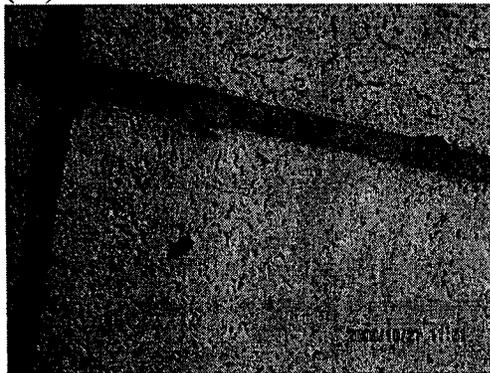
3. Look at the ceiling tiles at the top landing outside of the Door 208. There are a couple of tiles that are damaged and appear to have been damaged during construction. *There are four tiles at the top landing that should have damaged areas touched up. See Photos #11-14.*

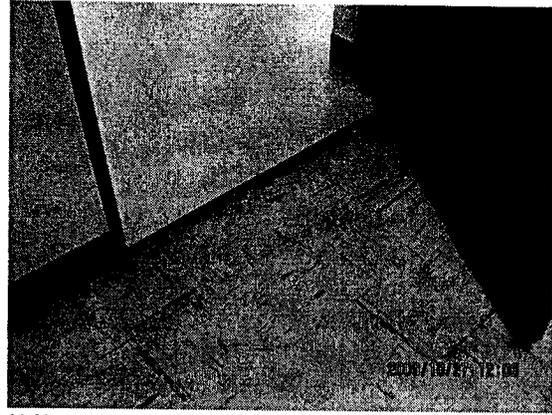
(18)

5. *There is a bad joint between the new and old tile at the door between the training rooms on the second floor. See Photo #18.*
6. *The floor transition between the new addition and the existing building at Door 105B and the opening in Corridor 109 leaves a high spot (approximately ¼ inch) that will cause the vinyl tile to crack. There are areas in both locations where the vinyl tile is not adhered to the concrete slab (hollow sound when tapping the tile). See Photos #19-24.*

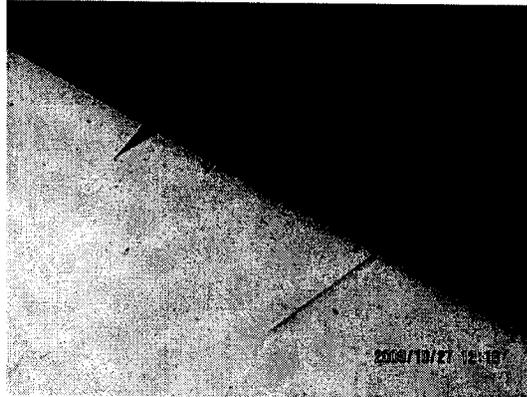
7. *There are loose tiles (at least two) along the south wall of the addition. See Photos #25-26*
8. *The bottom anchorage of the door frame to the elevator vestibule on the first floor at one location was improperly finished after the new tile was installed. A bent piece of the metal frame is left exposed above the floor tile. See photo #27.*
