STATE OF CONNECTICUT  
DEPARTMENT OF ECONOMIC AND COMMUNITY DEVELOPMENT  
INFRASTRUCTURE AND REAL ESTATE PROJECTS

**ENVIRONMENTAL ASSESSMENT CHECKLIST**

<b>Date:</b> 11/19/2013	<b>Staff Contact:</b> Nelson Tereso
<b>Municipality:</b> Bethel	<b>Project Name:</b> Francis J. Clarke Industrial Park Expansion
<b>Funding Source:</b> TBD	<b>State Funds:</b> TBD
<b>Type of State Agency Review</b>	<b>Stage 1</b> <u>  X  </u> <b>Stage 2</b> <u>      </u>

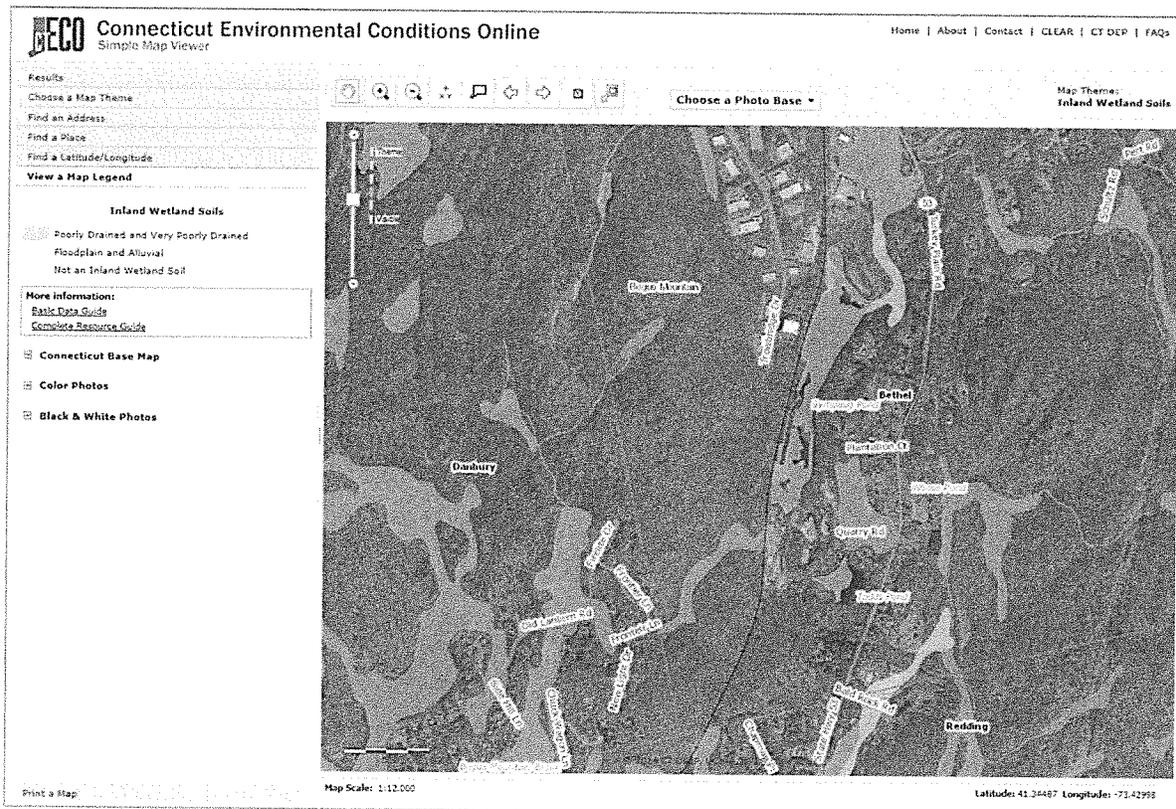
Inland Wetland Soils: There is a narrow wetland/watercourse trough south of Trowbridge Drive that drains easterly to the pond.

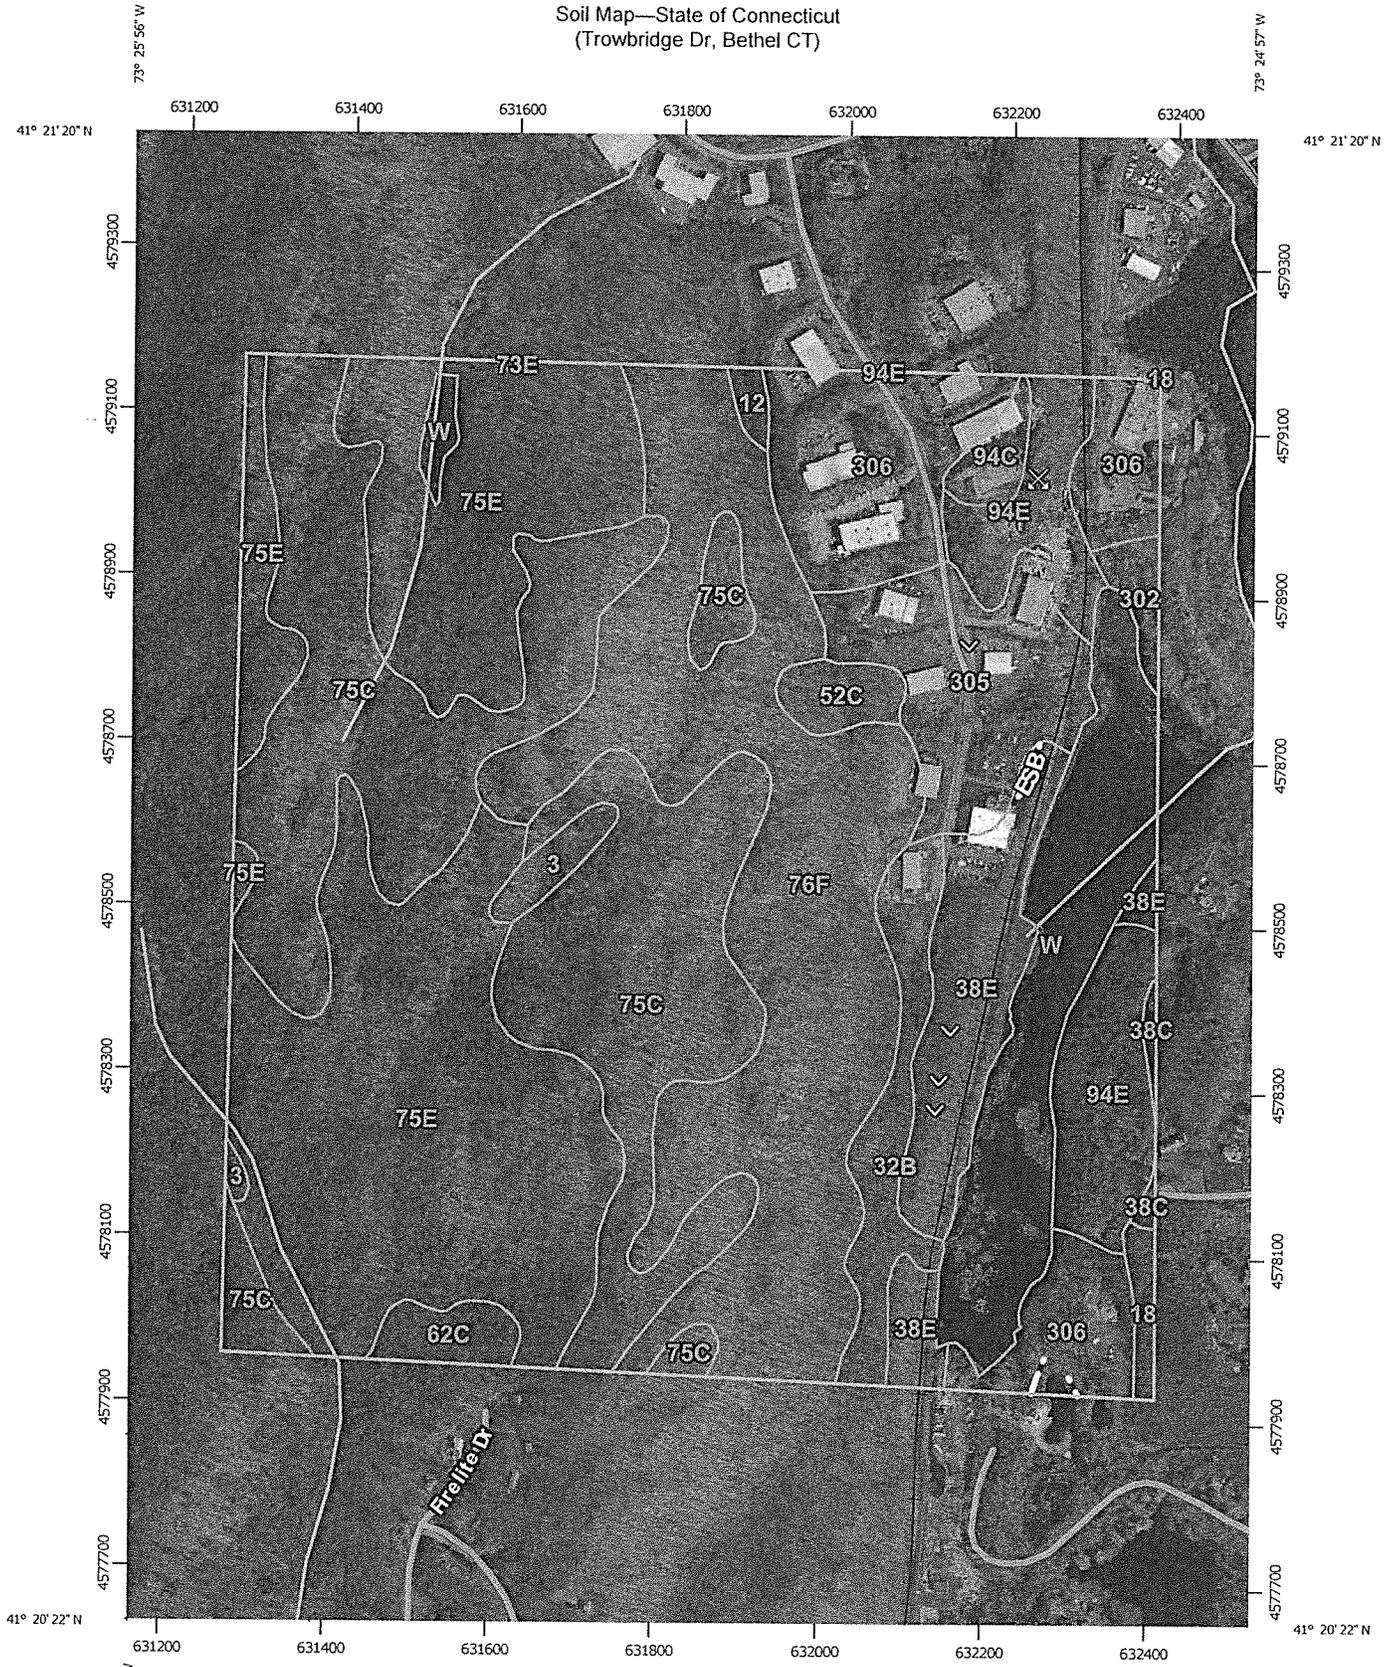
Soil Map—State of Connecticut  
(Trowbridge Dr, Bethel CT)

Map Scale: 1:8,790 if printed on A portrait (8.5" x 11") sheet.

State of Connecticut (CT600)			
Map Unit Symbol	Map Unit Name	Acres in AOI	Percent of AOI
3	Ridgebury, Leicester, and Whitman soils, 0 to 8 percent slopes, extremely stony	2.4	0.7%
12	Raypol silt loam	0.8	0.2%
18	Catden and Freetown soils	1.4	0.4%
32B	Haven and Enfield soils, 3 to 8 percent slopes	8.7	2.6%
38C	Hinckley gravelly sandy loam, 3 to 15 percent slopes	0.7	0.2%
38E	Hinckley gravelly sandy loam, 15 to 45 percent slopes	15.7	4.6%
52C	Sutton fine sandy loam, 2 to 15 percent slopes, extremely stony	2.8	0.8%
62C	Canton and Charlton soils, 3 to 15 percent slopes, extremely stony	2.9	0.9%
73E	Charlton-Chatfield complex, 15 to 45 percent slopes, very rocky	0.1	0.0%
75C	Hollis-Chatfield-Rock outcrop complex, 3 to 15 percent slopes	72.4	21.2%
75E	Hollis-Chatfield-Rock outcrop complex, 15 to 45 percent slopes	83.3	24.4%
76F	Rock outcrop-Hollis complex, 45 to 60 percent slopes	62.3	18.3%
94C	Farmington-Nellis complex, 3 to 15 percent slopes, very rocky	2.2	0.6%

94E	Farmington-Nellis complex, 15 to 35 percent slopes, very rocky	17.1	5.0%
302	Dumps	1.8	0.5%
305	Udorthents-Pits complex, gravelly	16.2	4.7%
306	Udorthents-Urban land complex	26.2	7.7%
W	Water	23.5	6.9%
<b>Totals for Area of Interest</b>		<b>340.7</b>	<b>100.0%</b>

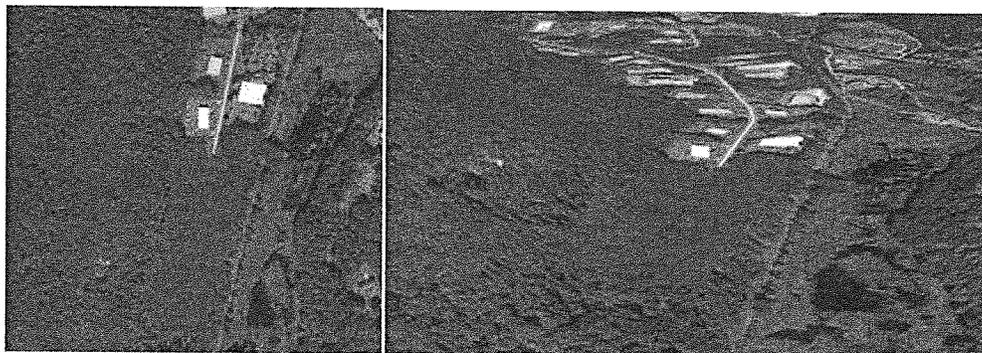
Existing Site – Images from Google Earth

The Site consists of an approximately 12-acre portion of land located south of Trowbridge Drive (dead end). The northern portion of Trowbridge Drive consists of an existing industrial park development. The project Site currently consists of undeveloped, wooded land. Vegetation at the Site generally includes a mixture of mature and immature growth. Ground surface regionally slopes upward from east to west, from Sympaug Pond (east of the Site, near elevation 375 feet) to a high point approximately 0.75 miles west of the Site (near elevation 740 feet). Within the Site boundary, the landform topography is generally concave. Ground surface is generally lower in the central portion of the Site (lower elevations typically ranging from approximately 414 feet to 425 feet). In the eastern portion of the Site, the ground surface rises to elevations ranging from approximately 466 to 438 feet before dropping steeply towards Sympaug Pond. In the western portion of the Site, ground surface rises to elevations ranging between approximately 464 feet and 504 feet (and continue to rise beyond the western Site boundary). The Conrail Railroad is located approximately 100 feet east of the Site and generally parallels the eastern edge of the Site.

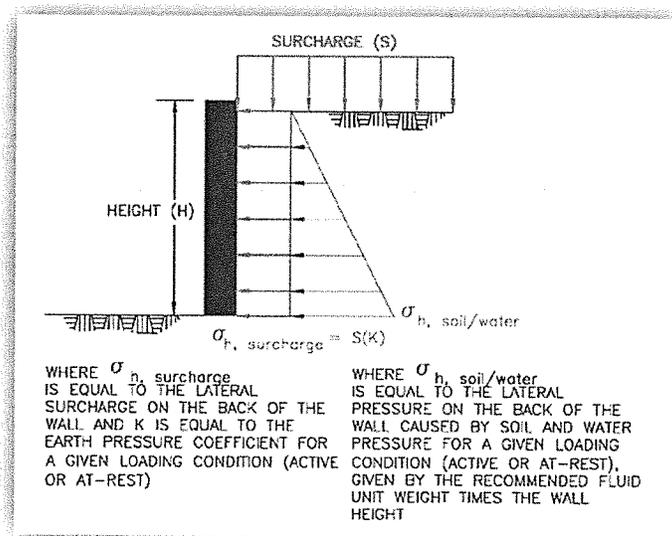
Diagram 1 – Lateral Earth Pressures for Earth Retaining Structures

Diagram 1 depicts the active and at-rest wall loading conditions described herein.

The lateral earth pressure recommendations given in the following paragraphs are applicable to the design of rigid retaining walls fixed against rotation or subject to slight rotation, such as cantilever or gravity type concrete walls. The recommendations are not applicable to the design of modular block - geogrid reinforced backfill walls.

In general, foundation walls, loading docks, and earth-retaining structures should be designed to resist lateral pressures generated by soil backfill materials and any temporary or permanent surcharge loads. At-rest conditions should be used for the design of loading dock walls, basement walls, and other walls that are not free to deflect or rotate. Walls that are free to deflect or rotate may be designed using active conditions. We assume that adequate drainage systems will be installed adjacent to below-grade structures (if planned), and thus hydrostatic forces have not been accounted for in the values provided herein. If

For sliding and overturning stability, the following design parameters are recommended for wall footings bearing directly on the native glacial till deposit, or on compacted structural fill or crushed stone placed above the native glacial till deposit or bedrock:

Unit weight of granular backfill:	135 pcf
Coefficient of sliding friction ( $\mu$ )	0.55
Maximum foundation edge pressure	5,000 psf

The recommended minimum factors of safety against sliding and overturning are 1.5 and 2.0, respectively. Lateral pressures are cumulative for computing overall safety factors. In no case should the lateral pressure be less than 200 psf (as a surcharge) to account for compaction equipment during construction. Wall backfill should be adequately drained to minimize hydrostatic forces behind walls. Structural fill meeting quality control testing criteria is recommended for backfill. For active pressure conditions to be developed, the wall must rotate about its base with lateral top movements of approximately 0.002H to 0.004H.

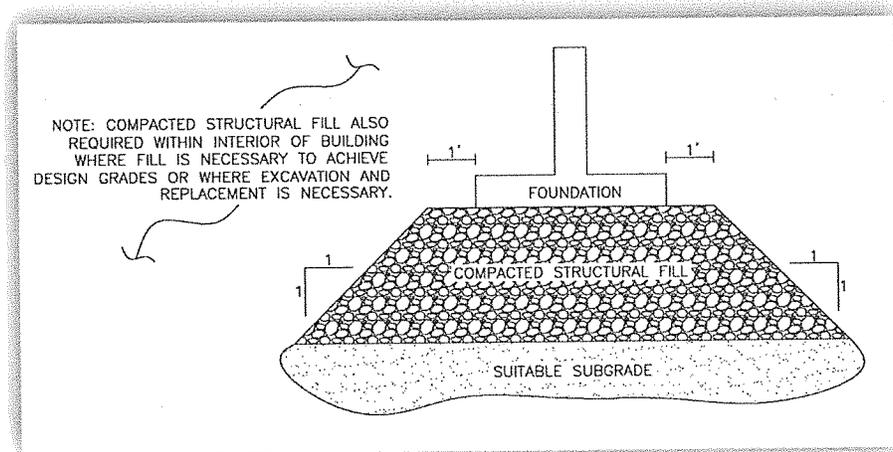
Diagram 2 – Minimum Foundation Bearing Zone

Where structural fill is placed below foundations (either as fill or backfill), the lateral extent of the structural fill should be the footing bearing zone. The footing bearing zone is defined as the 1H:1V lines extending downward and outward from the bottom outside edge of foundations (refer to Diagram 2).

General: Where structural fill is needed to achieve the foundation bearing elevations, structural fill should extend to the lateral limits defined by the 1H:1V lines extending downward and outward from the bottom outside edges of foundations (referred to herein as the "bearing zone," refer to Section 6.2).

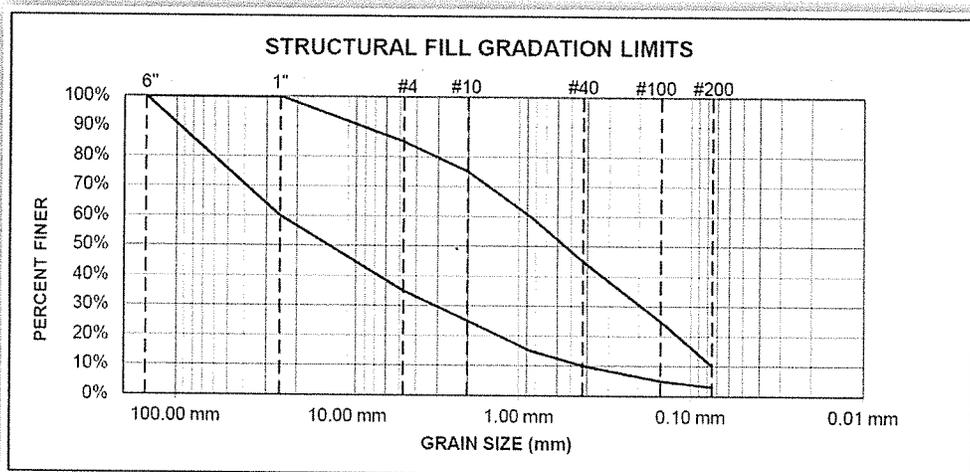
Diagram 3 – Structural Fill Gradation Upper and Lower Boundaries

Structural Fill		
Sieve Size	Percent Passing	
	Minimum	Maximum
6 inches	100	--
1 inch	60	100
No. 4	35	85
No. 10	25	75
No. 20	15	60
No. 40	10	45
No. 100	5	25
No. 200	3	10

Note: Maximum 3-inch particle size within 12 inches of foundation or slab subgrade elevation.

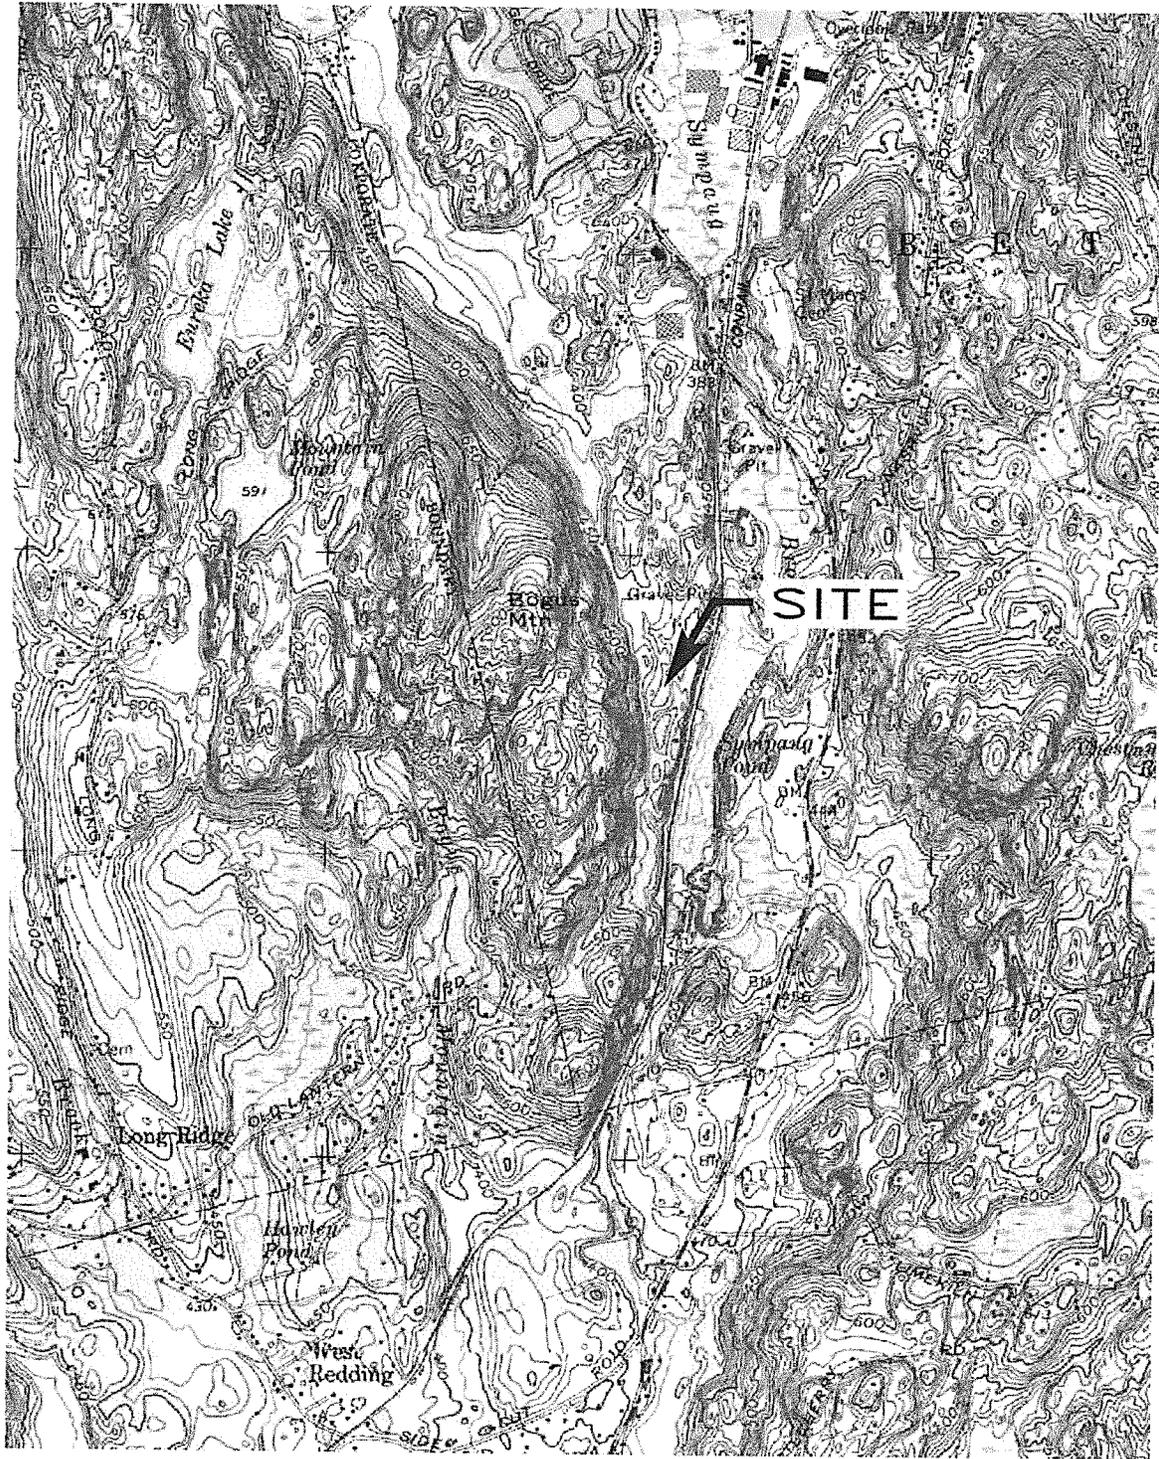
USGS BETHEL, CONNECTICUT  
TOPOGRAPHIC QUADRANGLE DATED 1985.

GeoInsight, Inc. (GeoInsight) is pleased to present this report describing the results of a geotechnical engineering assessment prepared for the Town of Bethel, Connecticut (the Town) for the above-referenced project. Included herein is our assessment of subsurface conditions as they relate to foundation design and earthwork construction for the proposed project located south of Trowbridge Drive (dead end road) in Bethel, Connecticut (the "Site;" see Figure 1).

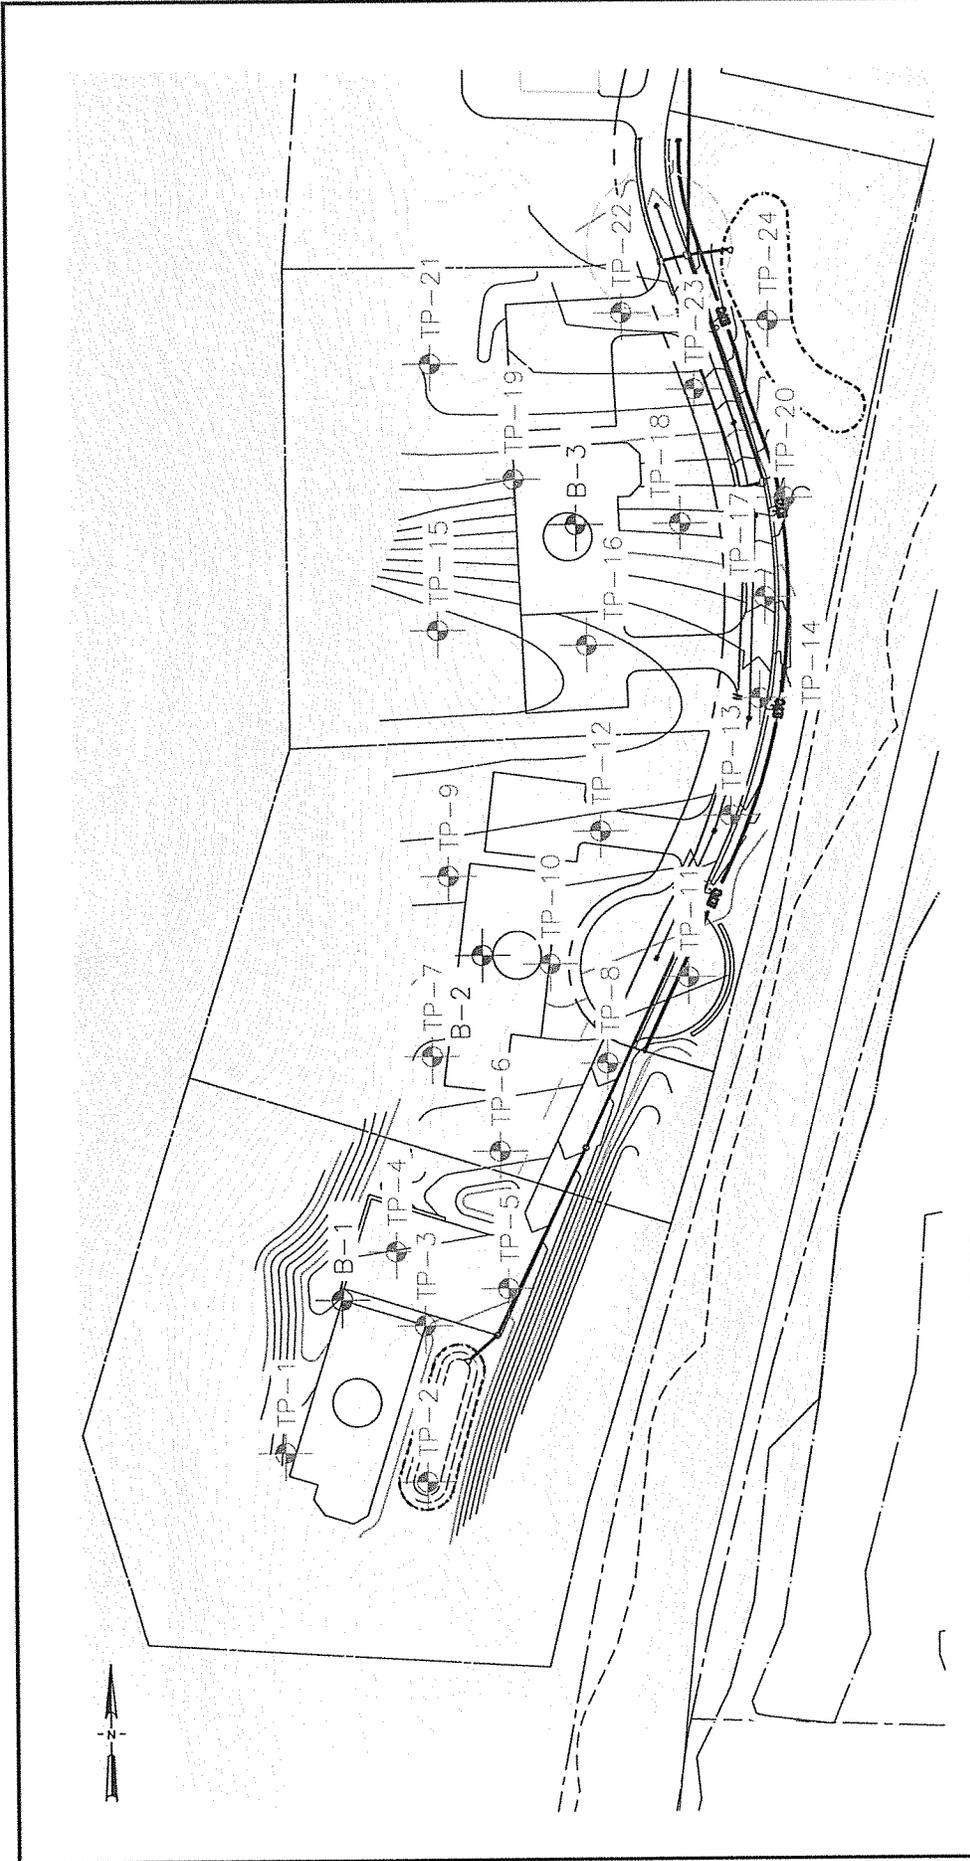
- B-1 APPROXIMATE SOIL BORING LOCATION AND DESIGNATION
- TP-4 APPROXIMATE TEST PIT LOCATION AND DESIGNATION

The soil profile and conditions outlined below highlight the major subsurface stratifications at the Site. The individual subsurface exploration logs should be consulted for detailed descriptions of the subsurface conditions encountered at each exploration location. When reviewing the test pit and test boring records and the subsurface profile, it should be understood that soil conditions might vary between and away from the exploration locations. The findings of this report are less likely to apply to areas not explored as a function of increased distance away from the specific subsurface exploration locations. Variations in subsurface conditions are possible laterally and with depth that are not identified on the logs or otherwise in this report. The subsurface conditions observed in the test pits and test borings are summarized in Table 1, attached.

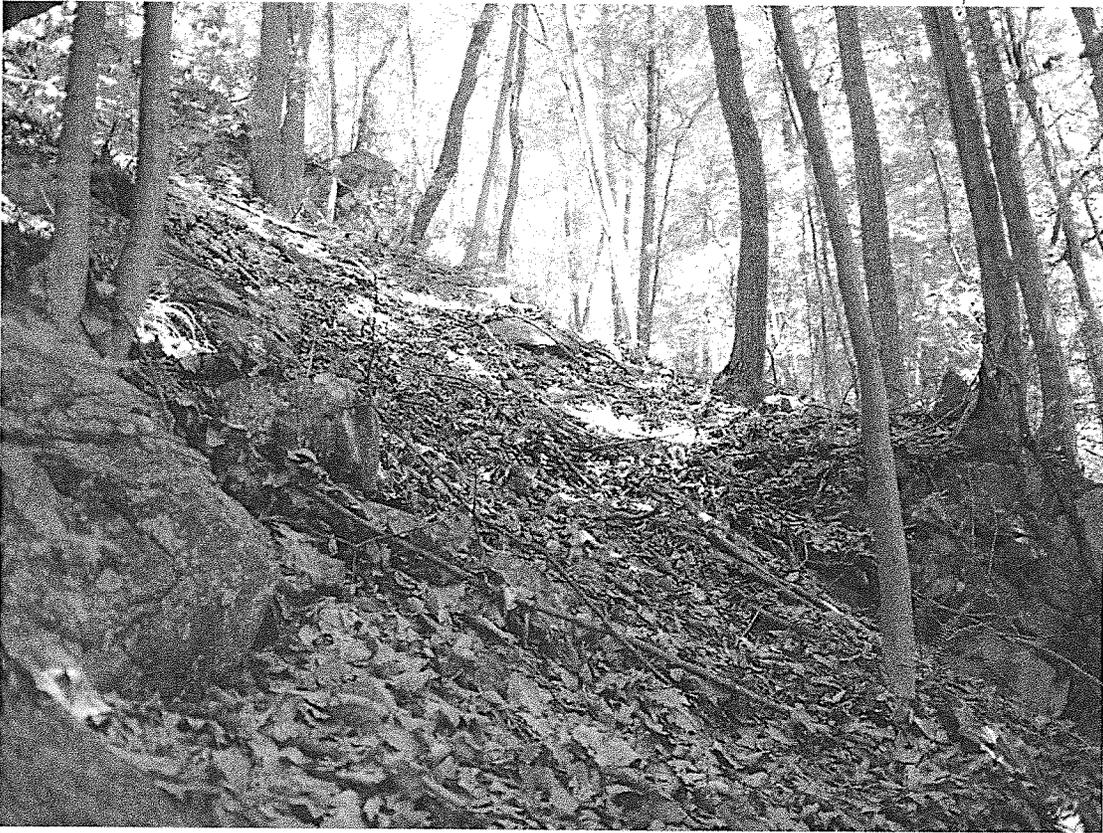
Figure 2. View upslope (northwestward) from upper talus section, showing deep leaf litter, steepness of slope and presence of gneissic outcroppings and boulders, which is typical of western portion of the site.

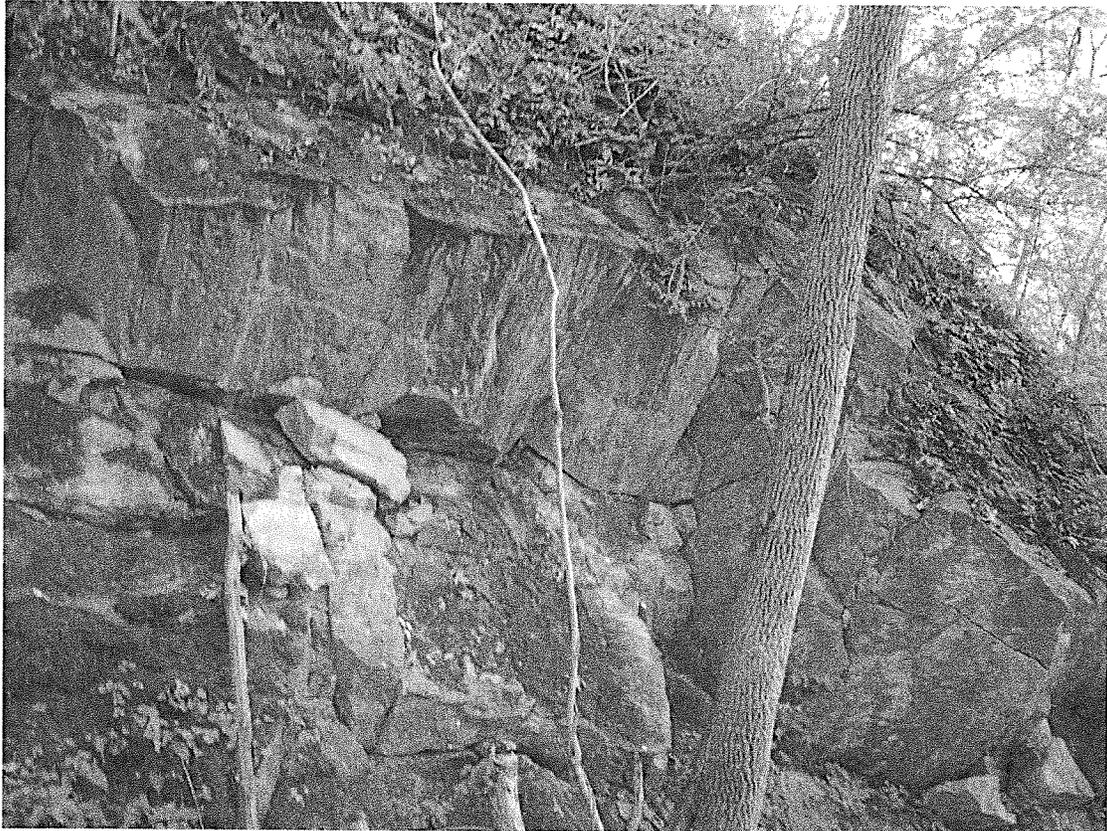
Figure 3. Calcitic/dolostone exposure along lower slope of southeastern-most section. Evidently this type of bedrock closely underlies the entire eastern side of the site, giving it a different character than western side.

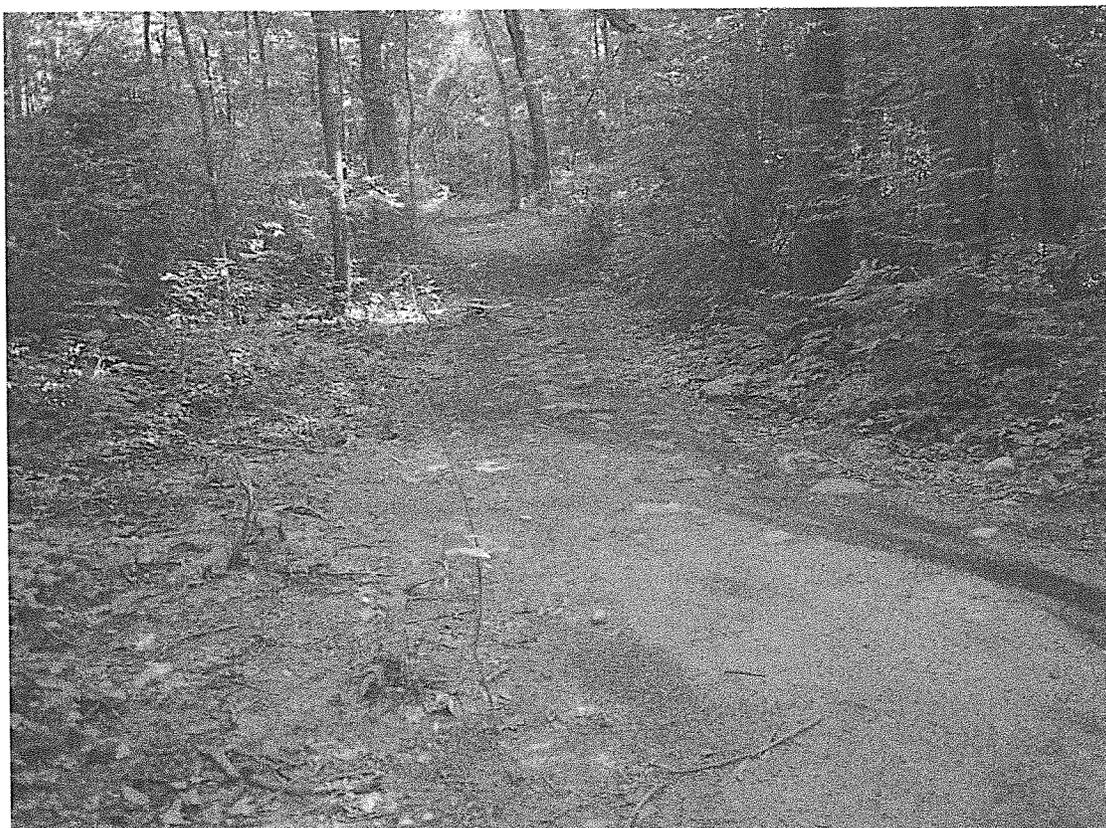
Figure 4. Southward view of informal trail/ORV track through central axis of site showing width (15+ feet) and degree of disturbance. In addition to soil erosion and compaction, and complete removal/suppression of natural vegetation in places, the ground layer of this section supports a different, markedly weedier flora than rest of the site.

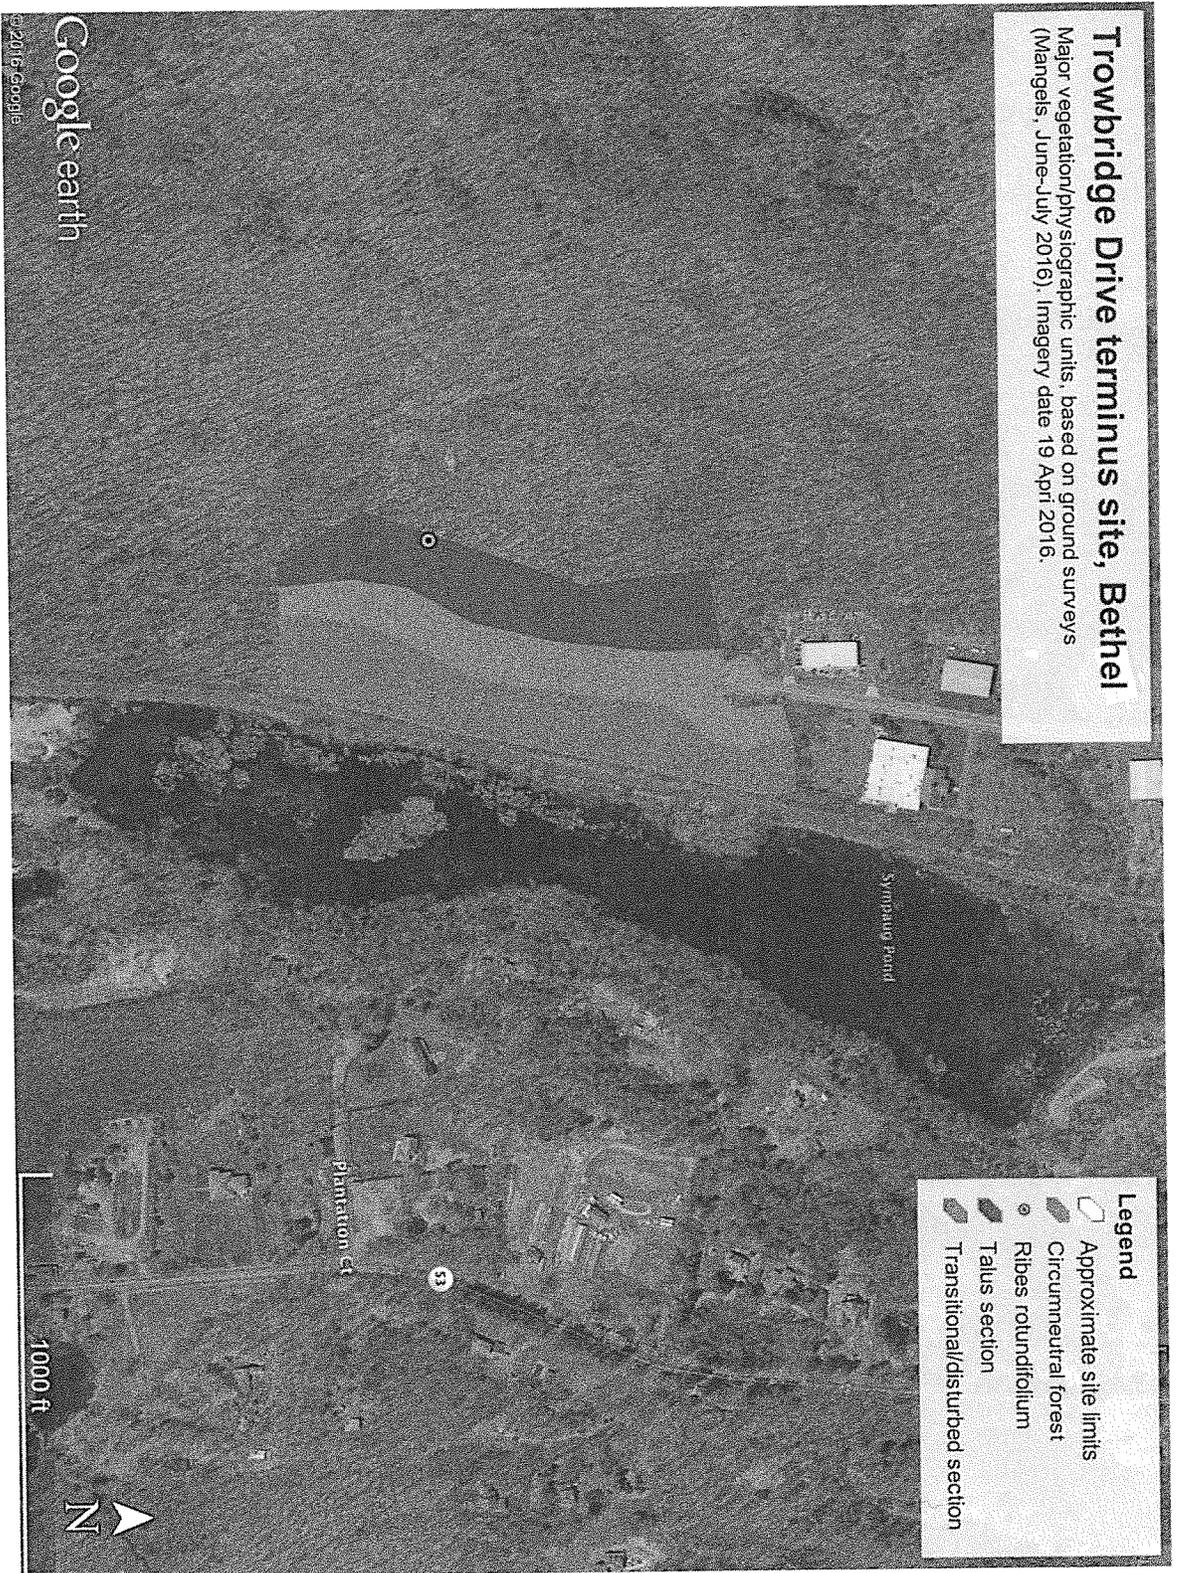
Figure 6.

Figure 6 (next page). Aerial image (circa April 2016) overlay showing approximate boundaries of site and constituent vegetation/natural community types, and precise (GPS) location of State-listed plant species.
